Report of the Portfolio Holder for Housing and Planning**Virement of Funds within Housing Capital Programmes.****Exempt Information**

Asbestos Refurbishment Survey

Site Address: 58 Stanhope House, Lichfield Street, Tamworth B79
7BN
Report Prepared for: Wates Tamworth - Planned
Report Reference: S-10826
Date Completed: 08/09/2022

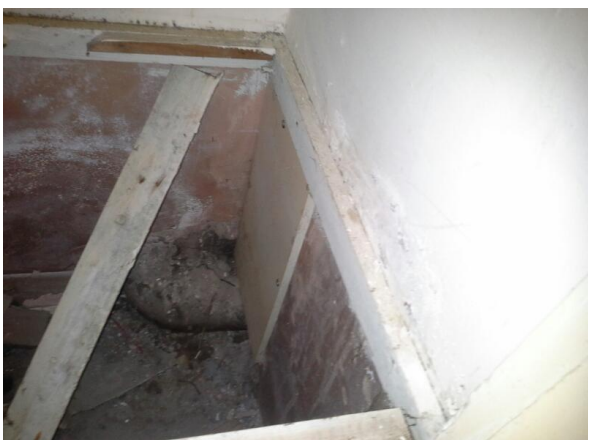
Sample No.	S-10826/S002

Property	58 Stanhope House, Lichfield Street, Tamworth B79 7BN		
Building / Floor	Main Building	0	
Location	drying cupboard		
Accessibility	Difficult		
Position	panel to wall under wood shelf		
Material	Cement Product		
Extent			
Analytical Results	NAD		
Material Assessment			
Action Date	19/09/2022		
Description of remedial works required / comments	No recommendation required

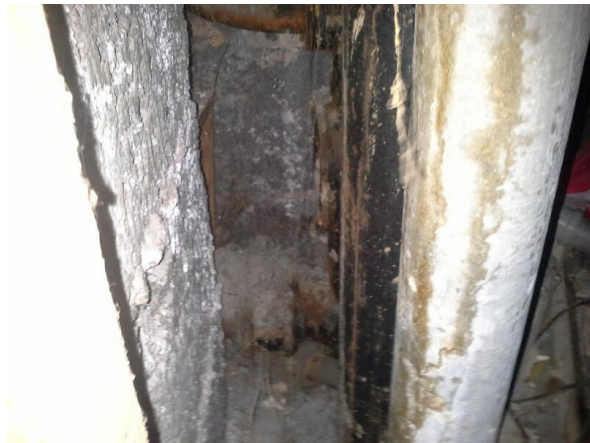
Sample No.	S-10826/S003

Property	58 Stanhope House, Lichfield Street, Tamworth B79 7BN		
Building / Floor	Main Building	0	
Location	void space		
Accessibility	Difficult		
Position	gasket to soil pipe		
Material	Gaskets (compressed)		
Extent			
Analytical Results	NAD		
Material Assessment			
Action Date	19/09/2022		
Description of remedial works required / comments	No recommendation required

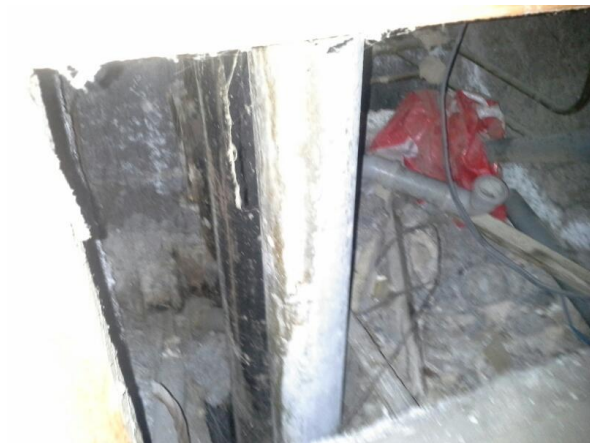
Sample No.	S-10826/S004

Property	58 Stanhope House, Lichfield Street, Tamworth B79 7BN		
Building / Floor	Main Building	0	
Location	void space		
Accessibility	Difficult		
Position	waste pipe		
Material	Cement Product		
Extent	1m		
Analytical Results	Chrysotile		
Material Assessment	3 - Very Low		
Action Date	19/09/2022		
Description of remedial works required / comments	Encapsulate, label & manage. Remove if planned works will impact upon material.

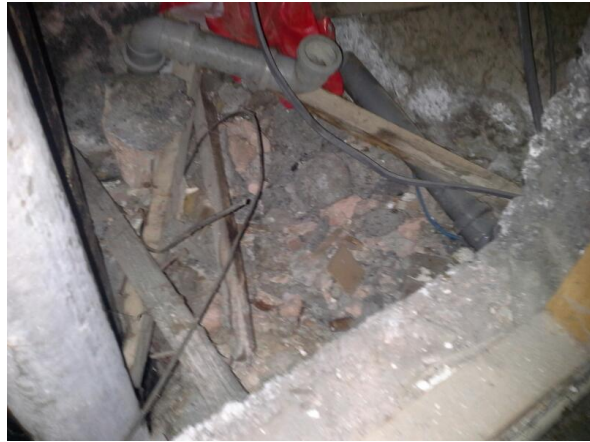
Sample No.	S-10826/S005

Property	58 Stanhope House, Lichfield Street, Tamworth B79 7BN		
Building / Floor	Main Building	0	
Location	void space		
Accessibility	Difficult		
Position	floor tiles and adhesive debris		
Material	Vinyl/ Bituminous Product		
Extent			
Analytical Results	Chrysotile to bitumen		
Material Assessment	3 - Very Low		
Action Date	19/09/2022		
Description of remedial works required / comments	Restrict access and remove

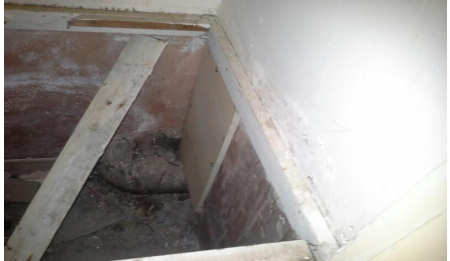
Building / Floor	Location	Material Description	Sample Number	I.D Result	Extent/Quantity	Photo No.
Main Building / 0	001 - drying cupboard	Cement Product	2	NAD	0.2m ²

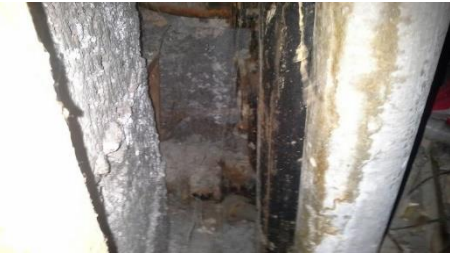
Main Building / 0	002 - void space	Gaskets (compressed)	3	NAD	1

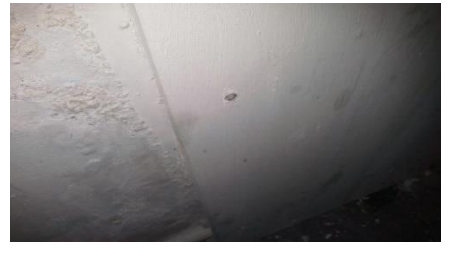
Main Building / 0	002 - void space	Cement Product	2	NAD	0.4m ²
