Asbestos Refurbishment Survey

Site Address: 58 Stanhope House, Lichfield Street, Tamworth B79
7BN
Report Prepared for: Wates Tamworth - Planned
Report Reference: S-10826
Date Completed: 08/09/2022

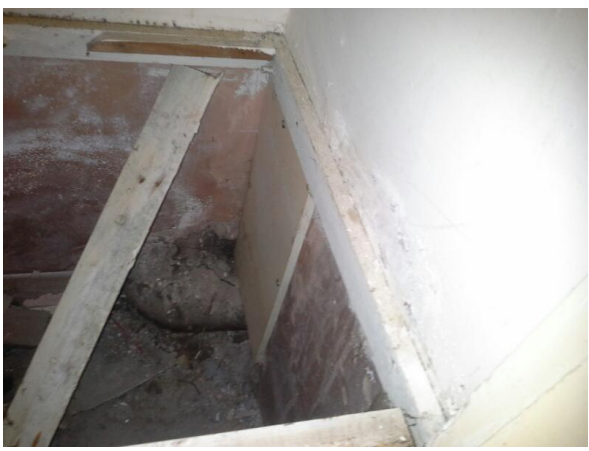
Sample No.	S-10826/S002

Property	58 Stanhope House, Lichfield Street, Tamworth B79 7BN		
Building / Floor	Main Building	0	
Location	drying cupboard		
Accessibility	Difficult		
Position	panel to wall under wood shelf		
Material	Cement Product		
Extent			
Analytical Results	NAD		
Material Assessment			
Action Date	19/09/2022		
Description of remedial works required / comments			No recommendation required

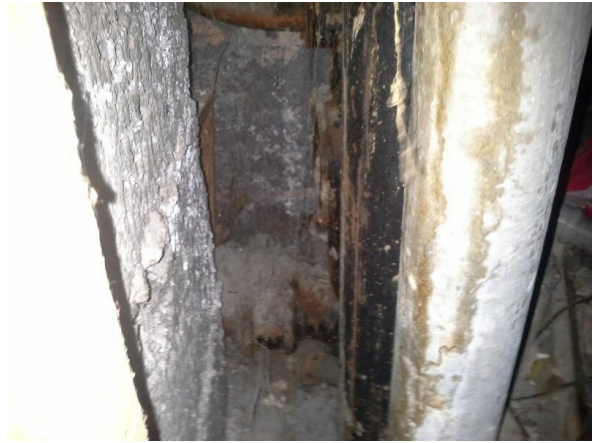
Sample No.	S-10826/S003

Property	58 Stanhope House, Lichfield Street, Tamworth B79 7BN		
Building / Floor	Main Building	0	
Location	void space		
Accessibility	Difficult		
Position	gasket to soil pipe		
Material	Gaskets (compressed)		
Extent			
Analytical Results	NAD		
Material Assessment			
Action Date	19/09/2022		
Description of remedial works required / comments	No recommendation required

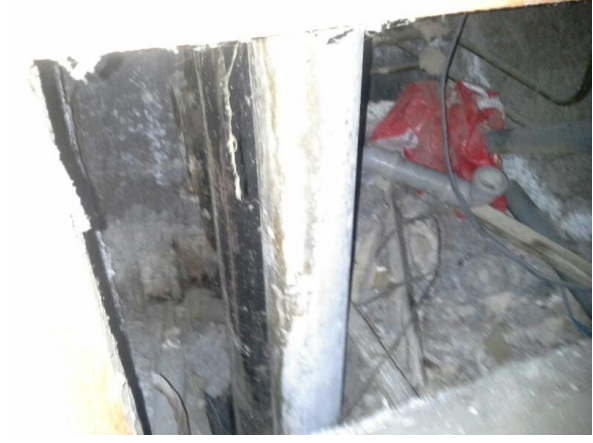
Sample No.	S-10826/S004

Property	58 Stanhope House, Lichfield Street, Tamworth B79 7BN		
Building / Floor	Main Building	0	
Location	void space		
Accessibility	Difficult		
Position	waste pipe		
Material	Cement Product		
Extent	1m		
Analytical Results	Chrysotile		
Material Assessment	3 - Very Low		
Action Date	19/09/2022		
Description of remedial works required / comments	Encapsulate, label & manage. Remove if planned works will impact upon material.

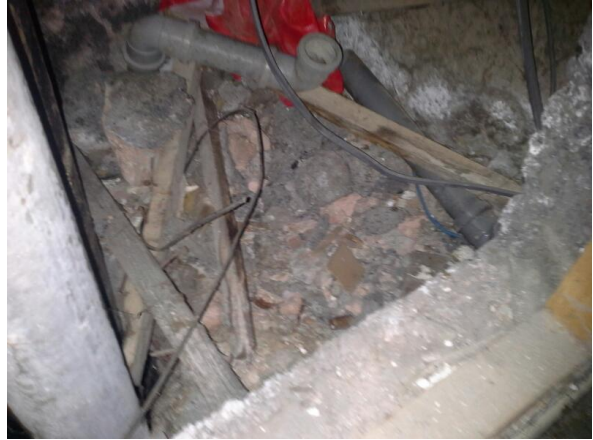
Sample No.	S-10826/S005

Property	58 Stanhope House, Lichfield Street, Tamworth B79 7BN		
Building / Floor	Main Building	0	
Location	void space		
Accessibility	Difficult		
Position	floor tiles and adhesive debris		
Material	Vinyl/ Bituminous Product		
Extent			
Analytical Results	Chrysotile to bitumen		
Material Assessment	3 - Very Low		
Action Date	19/09/2022		
Description of remedial works required / comments	Restrict access and remove

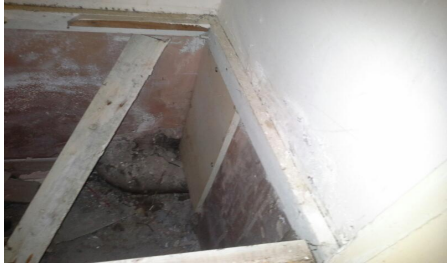
Building / Floor	Location	Material Description	Sample Number	I.D Result	Extent/Quantity	Photo No.
Main Building / 0	001 - drying cupboard	Cement Product	2	NAD	0.2m ²

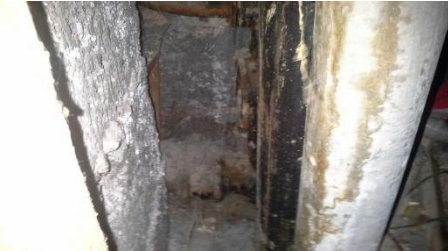
Main Building / 0	002 - void space	Gaskets (compressed)	3	NAD	1

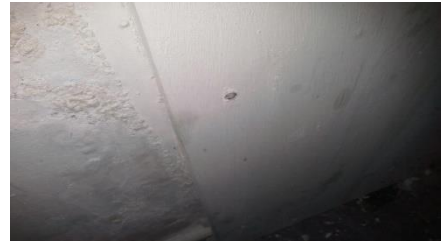
Main Building / 0	002 - void space	Cement Product	2	NAD	0.4m ²
