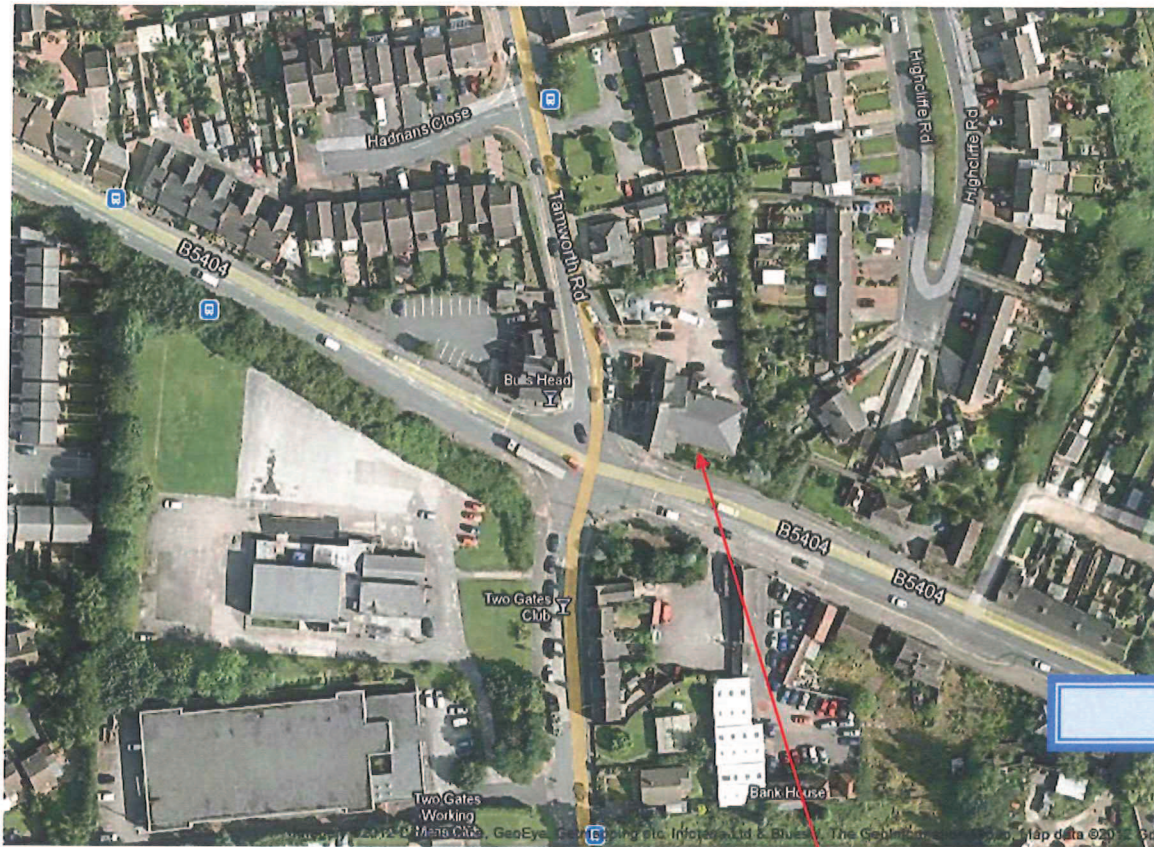
Figure 2.4 Aerial photograph showing Two-gates cross roads.

The aerial photograph of Two Gates Crossroads in Figure 2.4 highlights the building locations and the width of pavements and verges surrounding the crossroads.

Tube location Q6E is not close to relevant receptors as the building next to tube Q6E is used as a double glazed windows showroom with no living accommodation. There is living accommodation above the Bulls Head public house on the opposite side of the road which is likely to have similar concentrations.

Tube Q6S is located close to relevant receptors (row of 6 terraced houses).
